RECOVERING THE KURSK NUCLEAR HAZARDS

Peter Davidson PRINCIPAL SAFETY CONSULTANT, NNC LTD

John H Large Large & Associates CONSULTING ENGINEERS

ABSTRACT

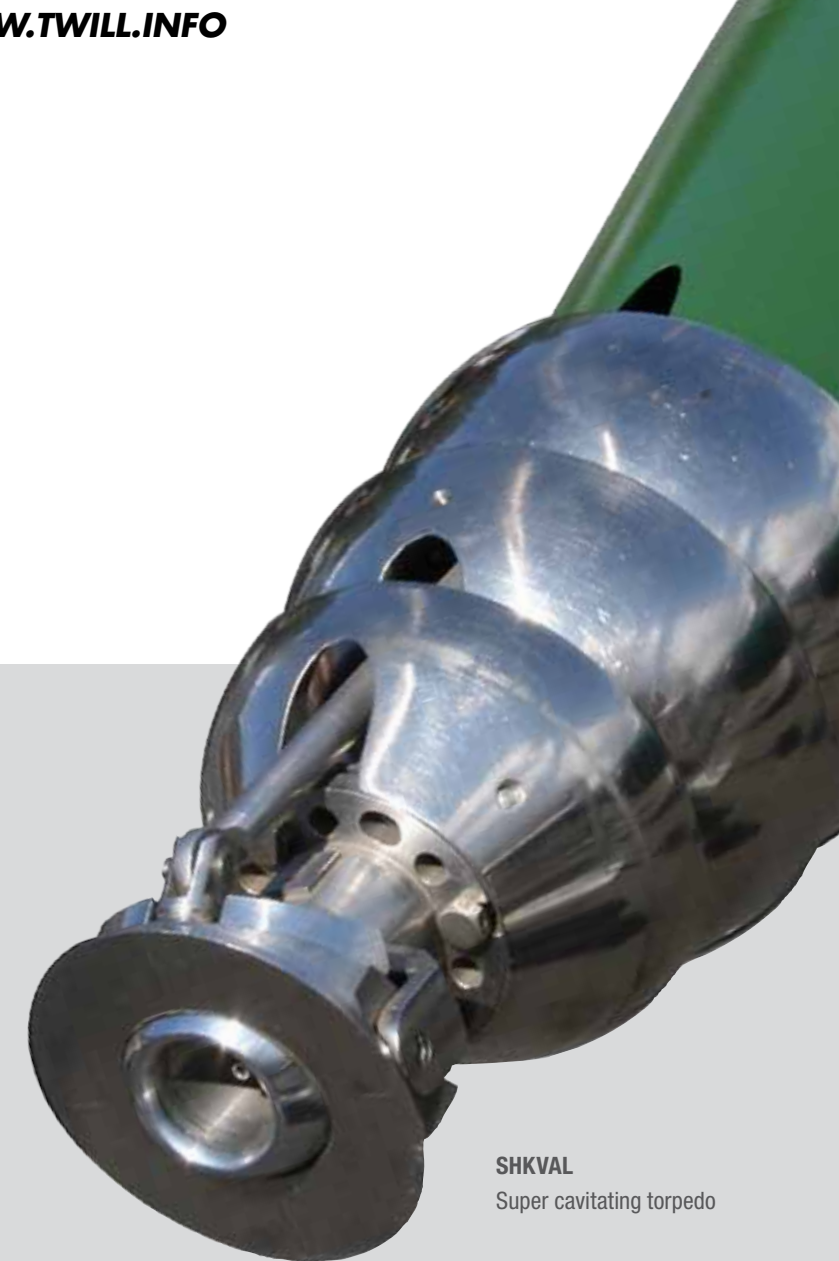
SHKVAL
Supercavitating torpedo

The prototype torpedoes were of the supercavitating type. This type of deep diving, high-speed torpedo envelops itself in a gas envelope generated at its bow with, essentially, the gas being replenished at the same rate as its progress through the water. The gas generating agent was hydrogen peroxide and, probably, the second prototype torpedo that initiated the sinking was an antisubmarine weapon (ASW) being deep diving and powered by a lithium-fluoride internal propulsion system.

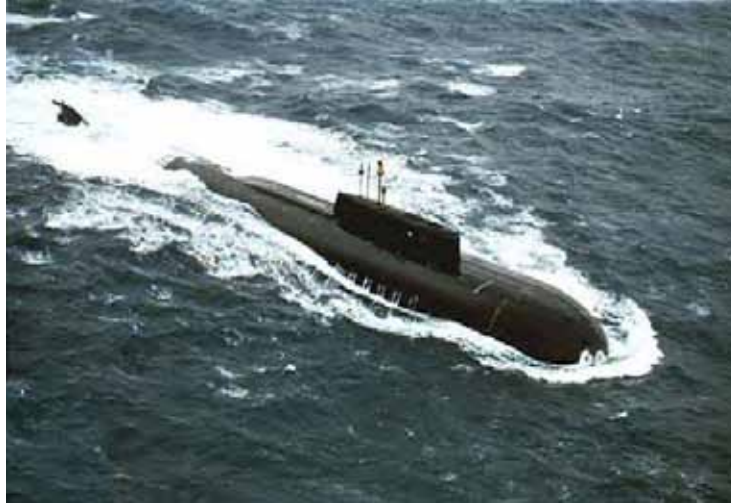
The damage sustained from this first explosion, which alone the Kursk could have withstood, can be pieced together from the first

of the two seabed debris fields. The debris included plates from the outer (flood) casing and, significantly, components of the port hydro-plane hydraulic mechanism and the forward ballast and trim tanks. At the time of the first explosion, Kursk was positioned for torpedo firing, at periscope depth in the sub surface layer where to assist with depth control and, to avoid porpoising, she would have been trimmed to negative buoyancy, maintaining her sea depth by driving hydrodynamically against her forward planes at up to about 6 knots. The centre of the first explosion seems to have been ahead of the foremost section of the pressure hull suggesting that the torpedo was loaded into the firing tube so, if the inner torpedo hatch was and remained closed, the damage to the bow compartment would have been minimal. However, the sonar trace taken by the nearby RF cruiser Pyotr Veliky shows continuing activity following the initial explosion spike, which could be interpreted as severe burning and jetting of the torpedo propellant system into the weapon stowage compartment (Compartment No 1).

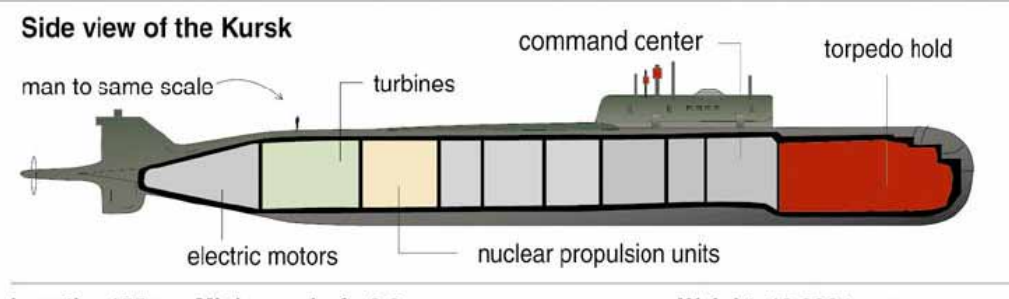
A most telling clue to the dying moments of the Kursk was the final position of a 4 by 2m section of forward section casing (the outer flood hull) on the seabed to starboard of the stern, having traveled the 154m length of the hull to its final resting place. This casing plate must have 'swum' from the point of the second explosion through the water down to the seabed; thereafter she drifted down and settled on the seabed at a depth of 110m. Analysis of this gives the Kursk at 30-35m above the seabed at the instance of the plate detachment.

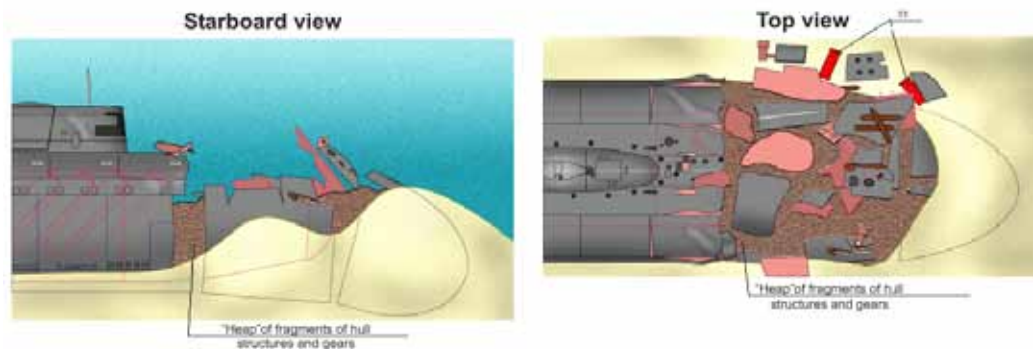
Destruction of forward end

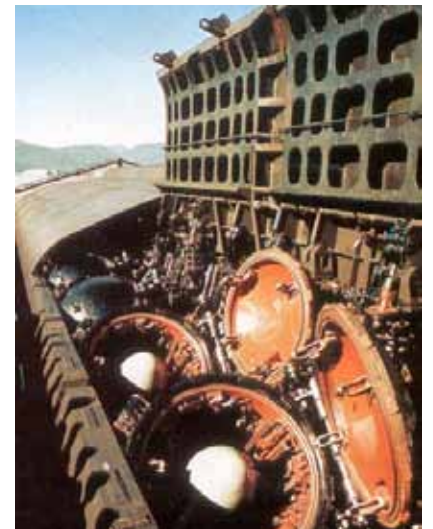
The Kursk submarine had an armament capacity for 24 ship-to-ship cruise missiles (SN-19-GRANIT - NATO Shipwreck) armed with 760kg main charge conventional explosive but nuclear capable for low yield warheads. The missiles were housed in individual pressure sealed silos, pitched forward at 40° arranged in two rows of twelve, each covered by six hatches on each side of the sail (conning tower).

Torpedo munitions comprised 24 torpedoes held in open rack magazines, potentially including torpedoes of nuclear capability, firing from 2x650mm and 4x533mm torpedo tubes in the bow (No 1) compartment. The armaments could also include ASW Harpoon-type rockets and seabed mines also deployed from the forward torpedo tubes.

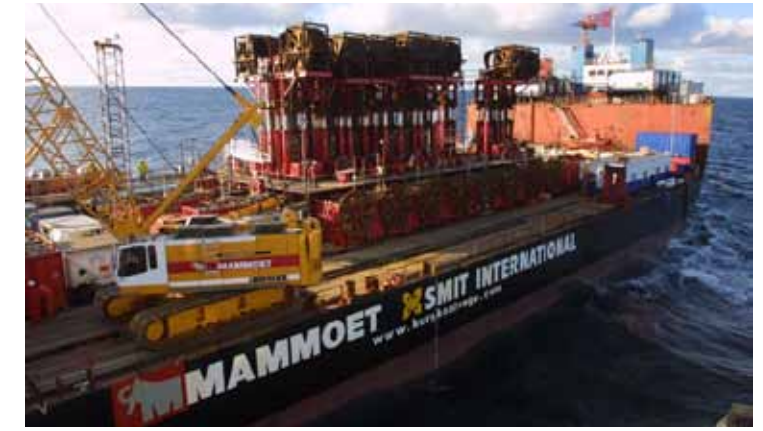
Lift, Sea, State and Other Factors: Limits on sea state had to be imposed during the lift and transit phases of the recovery operation. First, lifting operations could not proceed at sea state swell (peak to peak) heights greater than 2.5m because of the limit ram stroke of swell compensation system acting on the strand jacks - this system maintained a uniform cable tension during the lift. The entire 110m lift was scheduled for at a minimum period of 10 hours so a fair weather window of at least this was necessary to ensure safety throughout the lift. If weather conditions deteriorated during the lift then the lift would have to be abandoned and the Kursk lowered back to the seabed.

Second, during the transit phase when the Kursk was held against the under hull saddles of the Giant 4 and making way for port to dock with the floating dock, excessive sea state could result in slapping and pounding of the upper casing hull against the saddles and high forces being transmitted into barge frame. In these circumstances, either the Giant 4 would have to make for sheltered waters or the Kursk would have to be lowered to the seabed until clemency resumed. For one particular spell of the open sea transit, over a period of 3 to 4 hours, the distance to the coast and the sea depth precluded both of these options.

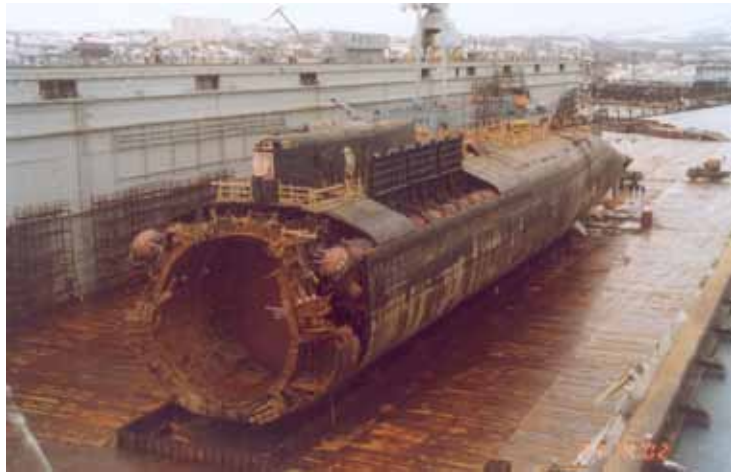
As well as the pre-prepared arrangements for response to a serious mishap to the Kursk during recovery (ie torpedo explosion, falling equipment, etc), the barge and support vessel crews had to work under a strict radiological management regime. This regime was administered by a radiation adviser overseeing shifts of health physics monitors surveying and managing contamination, dose receipt and recording, sheltering and other dose mitigation countermeasures. The NCG cooperated with the RF over analysis of a hypothetical radioactive release from the reactor compartment at the stage when the lifting Kursk approached close to the underside of the Giant 4 barge - this was assumed to be the point at which the barge crew were most at risk of radiation exposure.

- expansion of the air/gas bubble drives a discharge of 150m³ of water from the reactor compartment via the 6mm diameter instrumentation hole (a known open route into the reactor compartment), taking 36 hours.

- the discharged water contains fission and activation products released from fuel corroded for 14 months by seawater, as determined by a representative test, amounting to some 3x10¹² Bq (Becquerel). Allowing for dilution in the sea, the total effective dose to a barge crewmember would be less than 1 µSv (at less than 0.1 µSv/hour). Further development of this model analysis concluded that:
